# Chazey Court Farm Reading

Architectoral Recording  
and Analysis

**Client Name:** Williamson Associates Limited  
**Client Ref No:** ~  
**Document Title:** Chazey Court Farm, The Warren, Mapledurham, Berkshire  
**Document Type:** Building recording and analysis  
**Issue Number:** 1  
**National Grid Ref:** SU6914 7514  
**Planning Reference** 03/00194/5  
**OA Job Number:** 1904  
**Site Code:** CAVAZ03  
**Invoice Code:** CAVAZBS  
**Receiving Museum** Berkshire Museums Service  
**Museum Accession No** ~

MAPLEDURHAM ESTATE, THE WARREN READING.  
AGRICULTURAL STRUCTURES

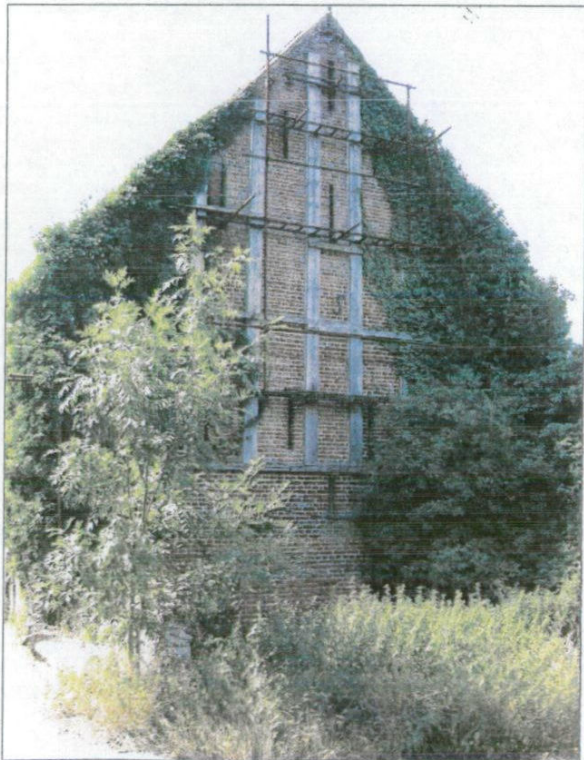
Plate 3 - East elevation of main barn, showing bracing to the brickwork.

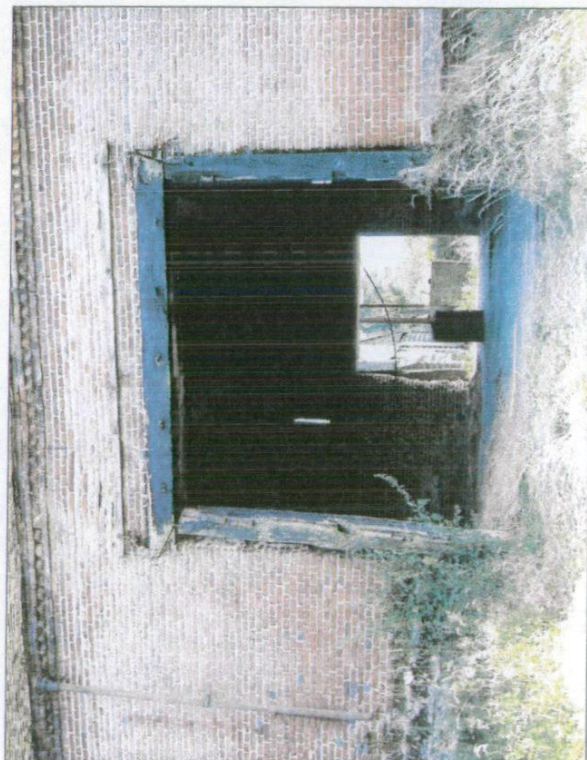
Plate 4 - North elevation doorway. Evidence of an overdoor roof is shown across the lintel.

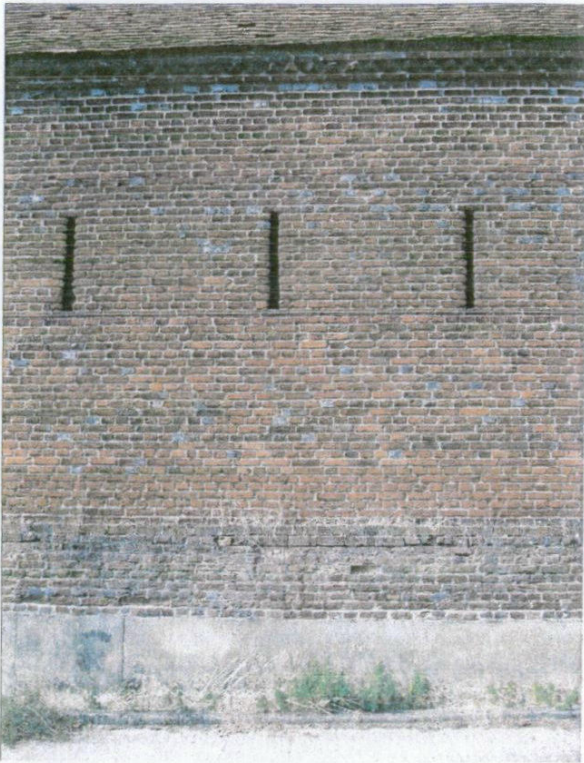
Plate 5 - South elevation of main barn, showing window openings, and concrete underpinning.

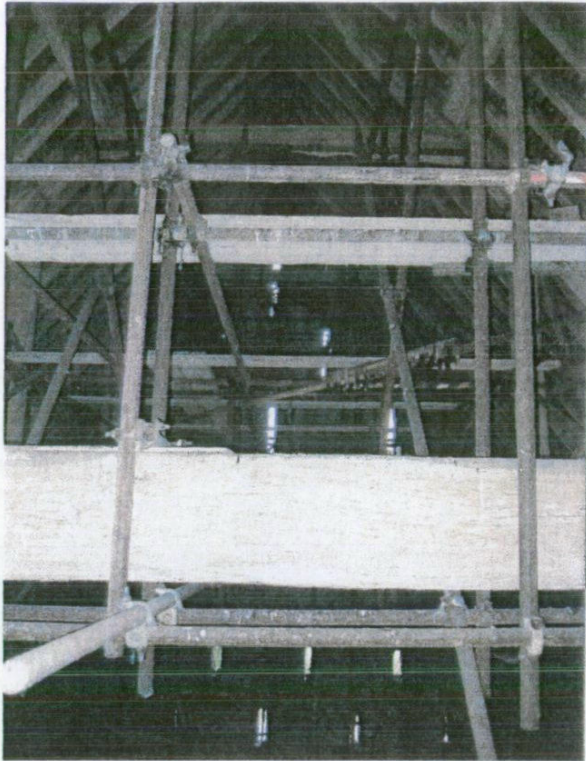
Plate 13 - Scaffolding to eastern end of roof.

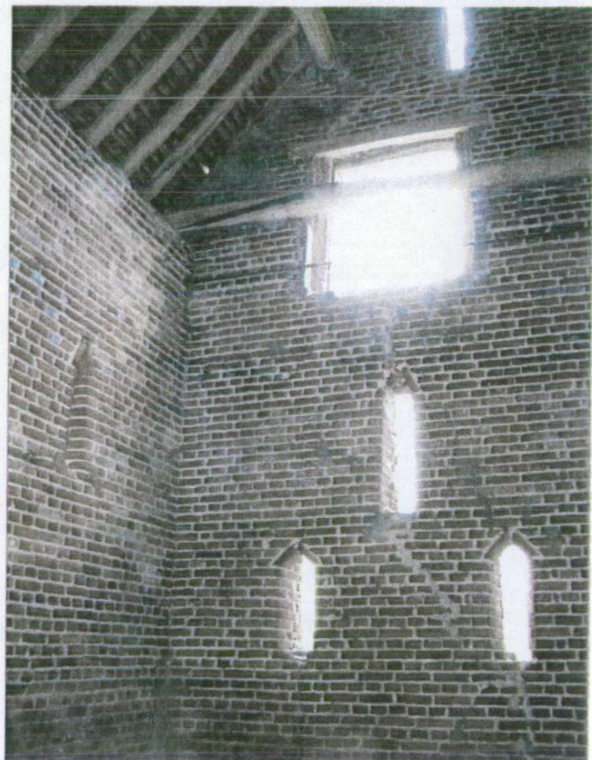
- 1.5 3 3 The only major alteration to the fabric is the insertion of a square window into the upper south side of the west wall, the timbers used in this appear to be a mixture of reused and new, the felling date for the newer timbers was fixed to summer or autumn of 1737.

Plate 16 - Internal west elevation showing inserted window.

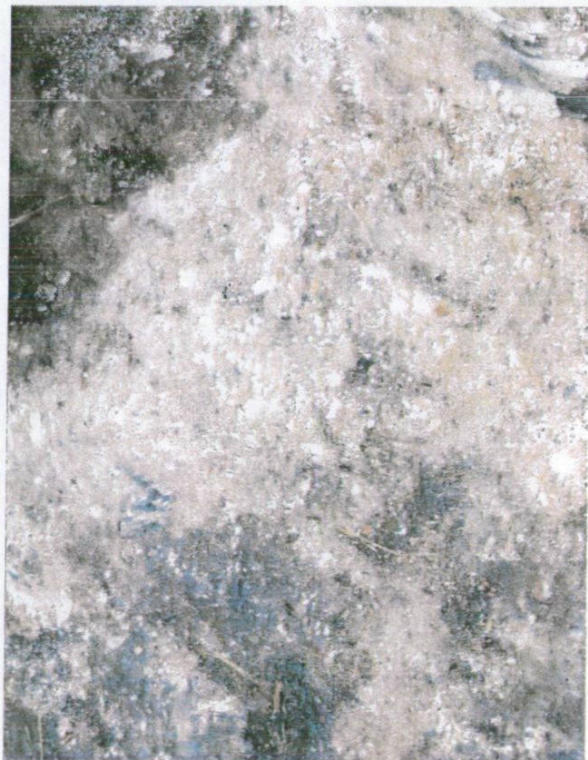
1 5 4 1 There are considerable areas of crushed lime, ash and clay flooring left in the barn, mostly at the west end, though straw and scaffolding prevented a thorough inspection of the eastern extents. It is not inconceivable that these are primary, and continue under much of the concrete flooring, these often show remains of internal divisions and structure placement. There are also signs that the north entrance way has been contoured to meet the barn's floor level, and although now covered with grass this may hide a cobbled or otherwise metalled surface, and possibly evidence of structures associated with animal management such as fencing lines, and relationships with the yard in general.

Plate 28 - Patches of lime, ash and clay flooring.

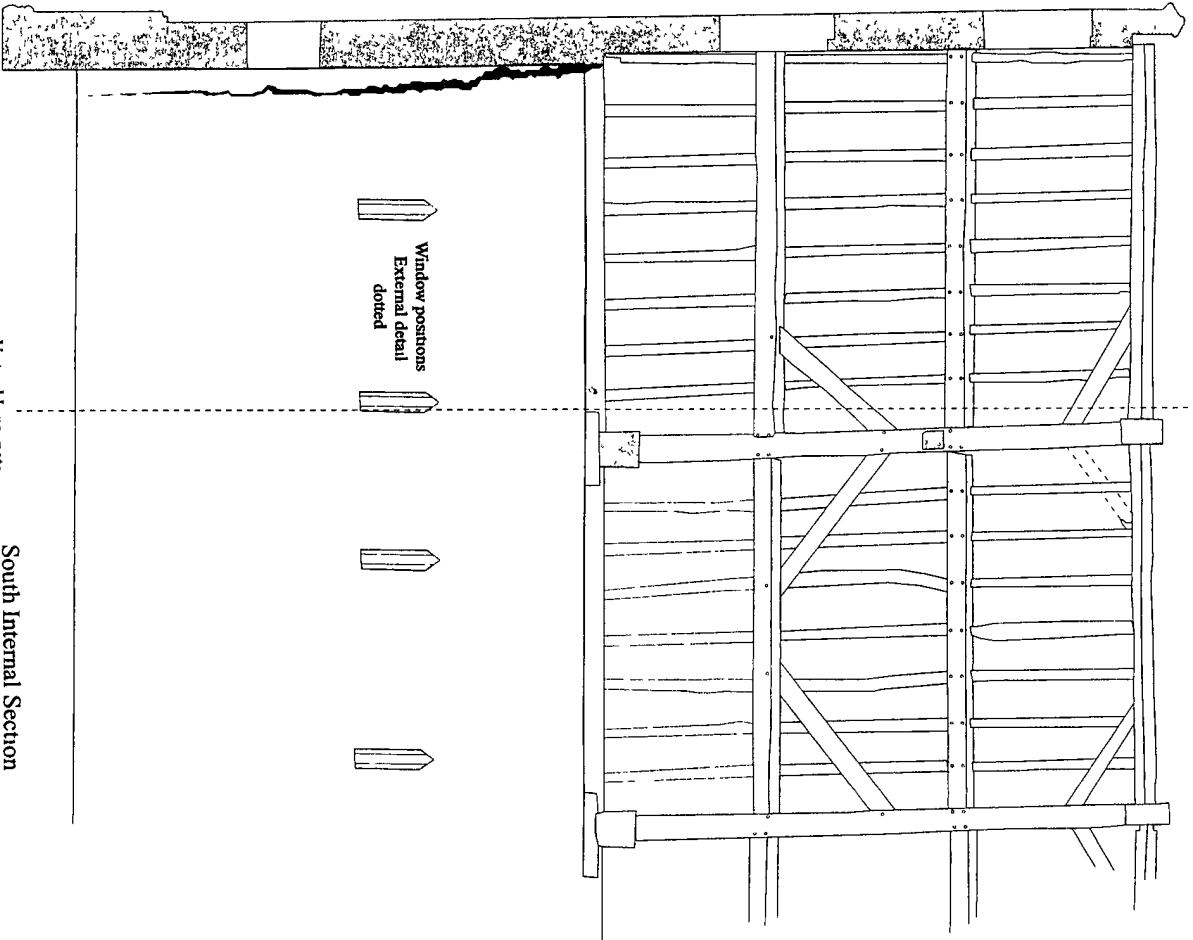
Figure 5 Internal South Elevation (part) and  
 East External Elevation  
 Scale at A4 1 10  
 0m 0.3m 1m

Vertical line, note  
 distortion of truss

South Internal Section  
 Showing lean in trusses and crack to south  
 wall Hand drawn over REDM Total  
 Station control at 1 25 Detail confirmed  
 from Miles and Co Drawing due to access  
 restrictions because of scaffolding

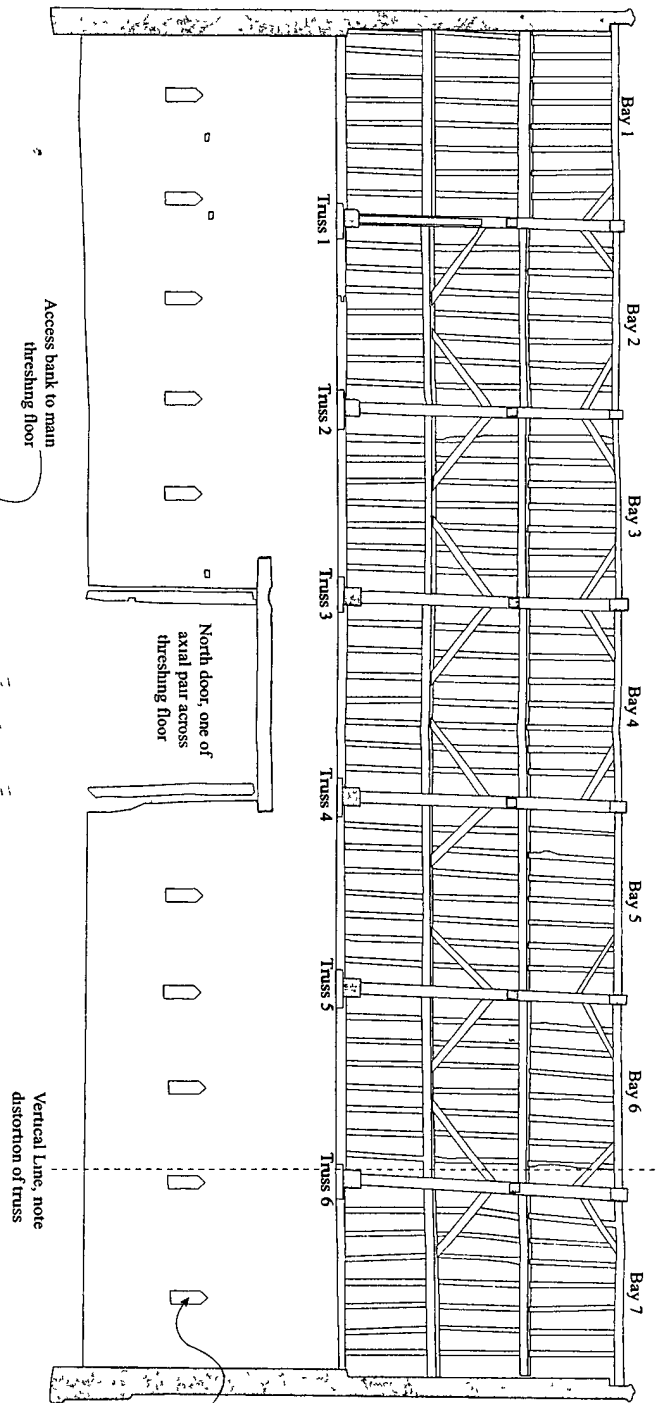
**North Internal Section**  
 Showing lean in trusses and schematic of roof. Hand drawn over REDM Total Station control at 1:25
