CADRA - Road Safety Albert Road/Highmoor Road Junction

17 October 2011

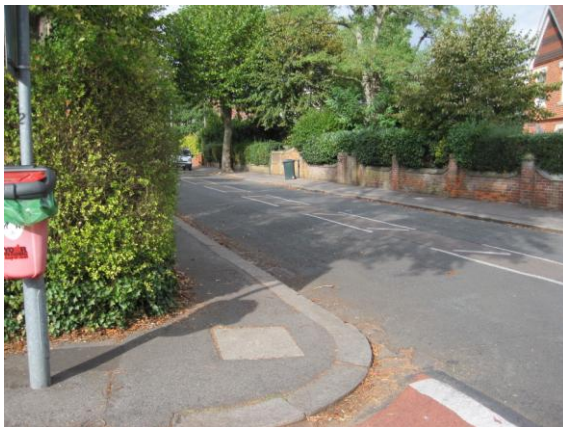
3.2 It is doubtful if Albert Road or Highmoor Road could be classed as a lightly trafficked road so a 2.4 metre 'X' distance is appropriate. The 'Y' distance to the right out of Highmoor Road (west) is 19.0 metres and to the left it is 16.5 metres on the kerbline and 36.2 metres to the centreline (not strictly appropriate as vehicles can cross the dotted hatched area). All of these measurements are substantially below the minima given in Manual for Streets. The photographs show views from Highmoor Road 2.4 metres from the stop line.

Highmoor Road(west) view to left

- 5.1 The primary problem for drivers emerging from Highmoor Road (west) is the poor visibility at the junction. The reasons for this are:
- the abrupt 12° bend in Albert Road at the junction;

- narrow footways (2.0m) and high hedges, fences or walls;
 - the CCTV cabinet, although it is 1.0m high it does obstruct the sight line; and
 - the tree on the eastern kerblines.

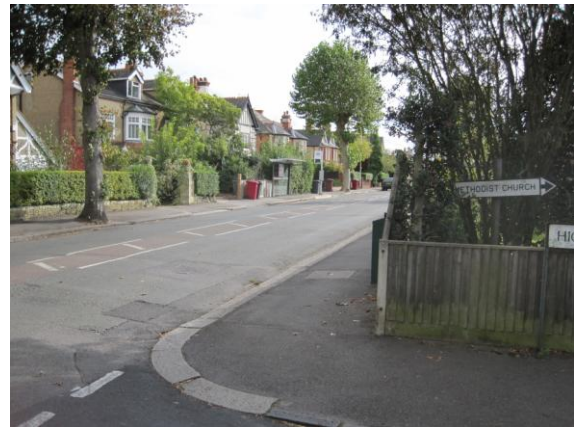
Highmoor Road(west) view to right

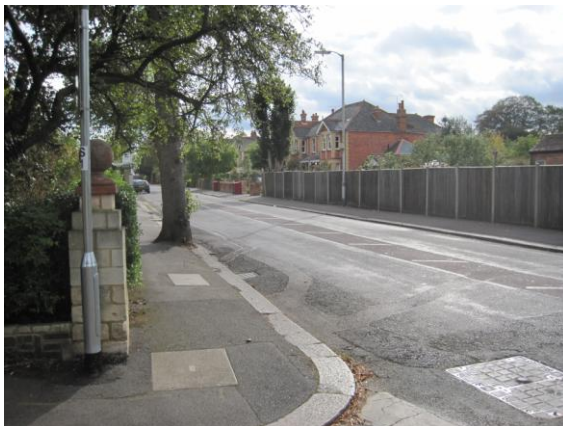
Highmoor Road(east) view to left

- 5.4 Visibility for drivers emerging from Highmoor Road (east) is better and is assisted by the bend in the road. However the view to the left is partly obscured by the large street tree and Albert Road drivers are also encouraged to keep left by the hatched road markings.

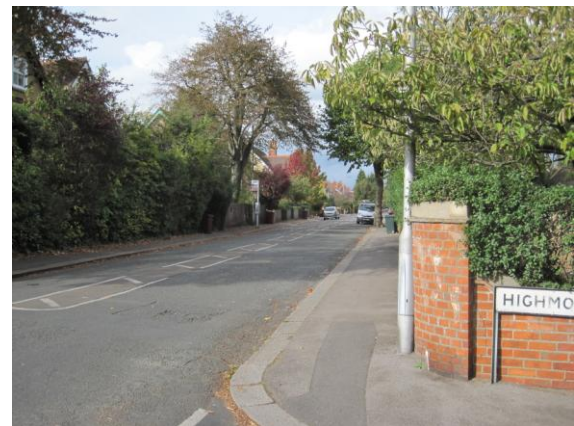
Highmoor Road(east) view to right

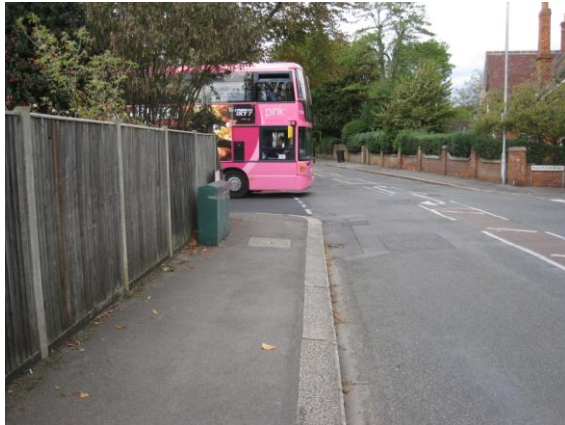
- 5.2 Therefore, drivers are forced to roll their vehicles forward of the stop line in order to see approaching traffic. The photographs show a bus and a car waiting to emerge from Highmoor Road. The bus driver has an advantage over the car driver as he sits closer to the front of the bus and high enough to see over many obstructions such as the green CCTV cabinet.

Bus waiting to enter Albert Road

(Nb. position of bus driver)

- 6.1 The hatched road markings are intended to narrow the running lanes and reduce traffic speeds. The current layout allows a small space for right turning vehicles but it is insufficient to allow straight-on vehicles to pass on the nearside. Unfortunately the hatched markings have worsened the collision risk.
- 6.2 It is suggested that the hatched road markings be removed and replaced with a simple centre of carriageway hazard line.
- 6.3 It is also suggested that the stop line for Highmoor Road (west) be advanced into Albert Road by 0.5 metre in a similar manner to the successful arrangement at the junction of The Warren with St Peter's Hill. The slight narrowing of the carriageway would also emphasise the junction and have a cautionary effect on drivers travelling on Albert Road.

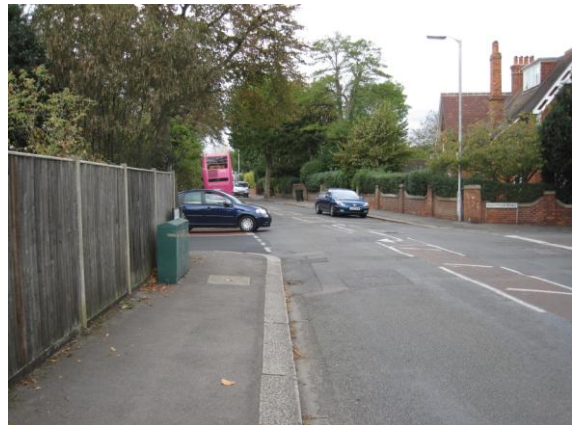
- 5.3 Due to the abrupt bend at the junction northbound drivers on Albert Road tend to travel close to the left hand kerblines. Unfortunately the centreline hatched road markings also encourage drivers to keep to the left. The combination of side road traffic having to creep forward with northbound traffic being close to the kerb results in vehicle collisions. If drivers do not roll forward of the stop line they are at risk of emerging into the path of traffic.

Car waiting to enter Albert Road

(Nb Albert Road car keeping close to eastern kerbline)
